NASA Technical Paper 2236

Galvanic Coupling Between D6AC Steel, 6061-T6 Aluminum, Inconel 718, and Graphite-Epoxy Composite Material: Corrosion Occurrence and Prevention

Merlin D. Danford and Ralph H. Higgins

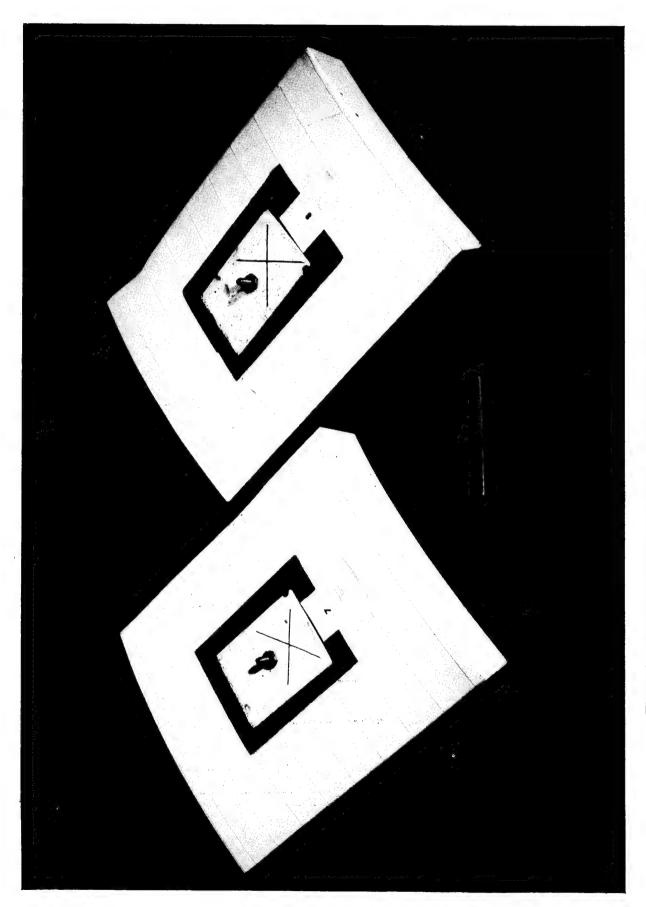
Photographs of the complete assemblies after removal from the 3.5% NaCl solution are shown in Figures 1 and 2 for tests 4 and 5 respectively. For test number 1, both the G/E and D6AC steel plate were in good condition, with no visible sign of rusting on the metal and no rust streaks on the G/E. Specimens 3 and 4, for test number 2, showed heavy rusting at the center of the scribe marks, with other rust spots being evident on the D6AC steel plates. Heavy rust streaks appeared on the G/E surface. For test number 3, small rust spots were evident at one corner of the D6AC steel plates on both specimens 5 and 6, with small rust streaks being evident on the G/E surfaces. In test number 4, a photograph of which is shown in Figure 1, all surfaces appeared in good condition with no rusting evident on the steel plates, numbers 7 and 8. For test number 5, shown in Figure 2, heavy rusting was evident along one scribe mark for steel specimen 9 and in the center of the scribe marks for steel specimen number 10. Heavy rust streaks appeared on the G/E surfaces in both cases. For test number 6, which comprised the test for aluminum samples, all surfaces appeared in good condition, although a small amount of white Al₂O₃ formed in the scribe marks on the aluminum plates. This condition was difficult to determine visually.

Figure 1. Complete assembly for test No. 4 after removal from 3.5% NaCl solution.

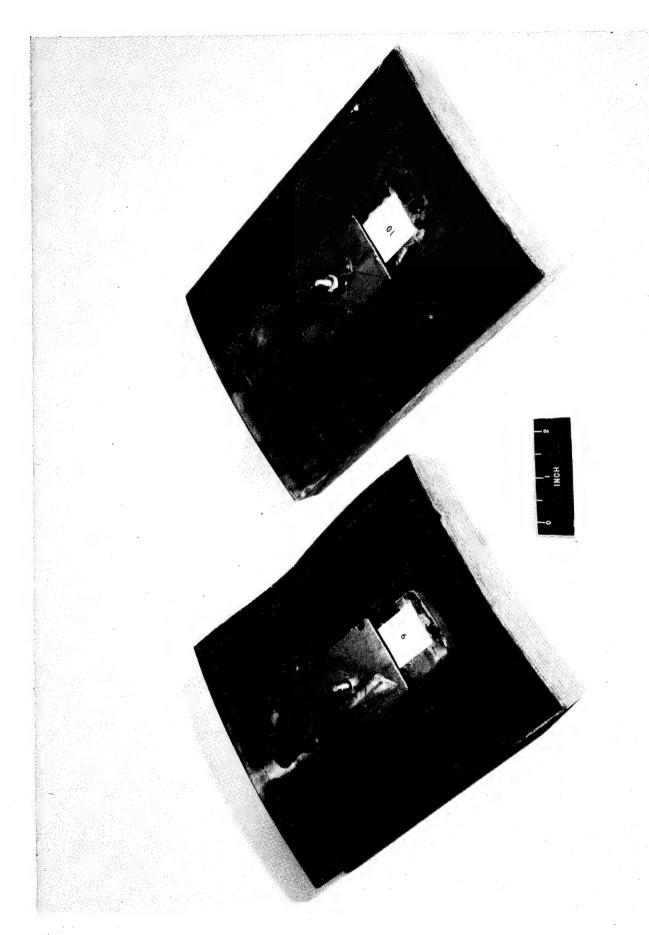
occurred at the scribe marks in the metal surfaces, where only Conoco grease served to protect the bare metal. The remainder of the metal surfaces, which were coated with zinc-rich primer and Conoco grease, appeared to be in relatively good condition. The same situation was present in test number 5, where the total G/E surfaces were left bare.

Figure 2. Complete assembly for test No. 5 after removal from 3.5% NaCl solution.

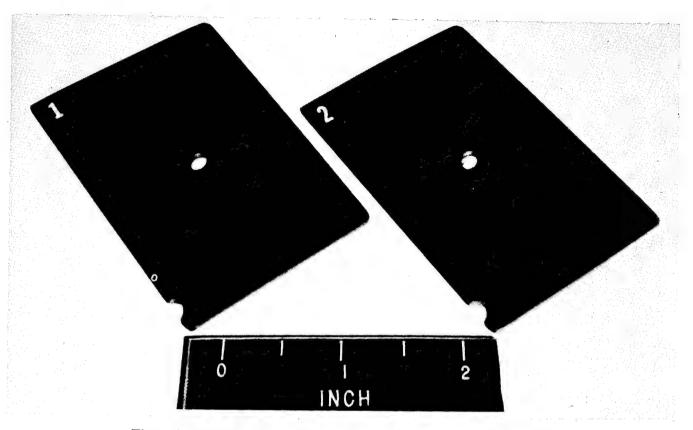
Paint was stripped from all metal samples after disassembly with Cee-Bee A-202 epoxy and polyurethane stripper, after which they were cleaned according to procedures described in ASTM G1-72 and weighed to determine weight loss. Photographs are shown in Figures 3 through 8 for the metal specimens in tests 1 through 6. Weight losses for each specimen are listed in Table 5, along with the average weight loss obtained in each test. For test number 1, the average weight loss was 32.1 mg, a rather small value, with the cleaned surfaces being in good condition. For test number 2, specimen number 3 exhibited a circular pit approximately 6 mm in diameter with corrosion all the way through the metal. The weight loss in this case was 246.7 mg. Specimen number 4 displayed a large oblong pit approximately 5 by 10 mm at the surface corroded to a depth of 1 mm. Weight loss for this case was 459.2 mg. The average weight loss for test number 2 was 353.0 mg. Specimens 5 and 6 for test number 3 had exhibited small rust spots at the corners. but the metal appeared in good condition after stripping and cleaning. This test showed an average weight loss of only 17.0 mg. For test number 4, where a topcoat had been applied over the zinc-rich primer, specimens 7 and 8 displayed an average weight loss of only 12.9 mg and appeared in very good condition. For test number 5, where the G/E surfaces had been left completely bare heavy corrosion occurred on both specimens. Specimen 9 displayed two large pits along one scribe mark. One of the pits was approximately 3 by 5 mm at the surface and had corroded to a depth of 1.5 mm. The other pit measured 5 by 7 mm at the surface and had corroded to a depth of 0.5 mm. Specimen number 10 exhibited a circular pit approximately 8 mm in diameter which had corroded all the way through the metal. Weight loss for these specimens averaged 389.4 mg. For test number 6, which involved the aluminum specimens and G/E completely covered with topcoat, the aluminum samples appeared in very good condition after cleaning, and exhibited an average weight loss of only 12,3 mg.

Figure 3. Metal specimens for test No. 1 after exposure and cleaning.

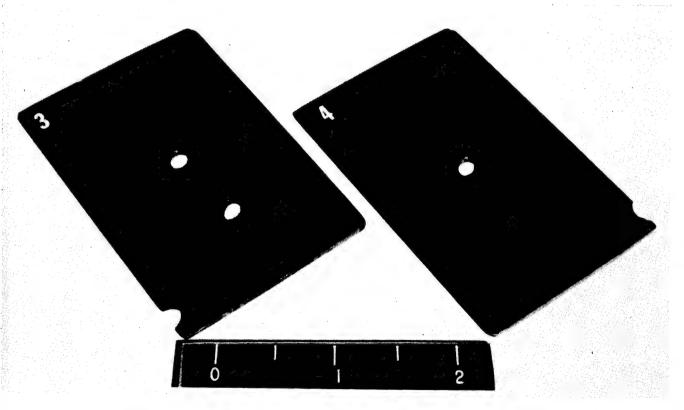
From the experimental results obtained, it is evident that the surfaces of the G/E must be completely coated, either with topcoat or a combination of polyurethane resin and topcoat. In test number 2, where only a polyurethane joint was employed with the remainder of the G/E surface left bare, heavy corrosion

Figure 4. Metal specimens for test No. 2 after exposure and cleaning.

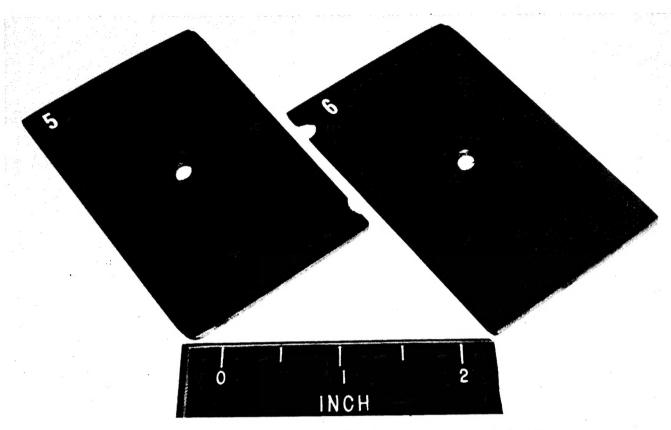
The results also indicate that, when the G/E is completely coated, satisfactory protection of the D6AC steel is achieved with either the zinc-rich primer or the primer/topcoat combination, as shown by comparing tests 3 and 4, which had very similar weight losses. This is true despite the small rust spots observed at the corners of the metal plates in test number 3. These may have been caused by sharp corners on the metal plates.

Figure 5. Metal specimens for test No. 3 after exposure and cleaning.

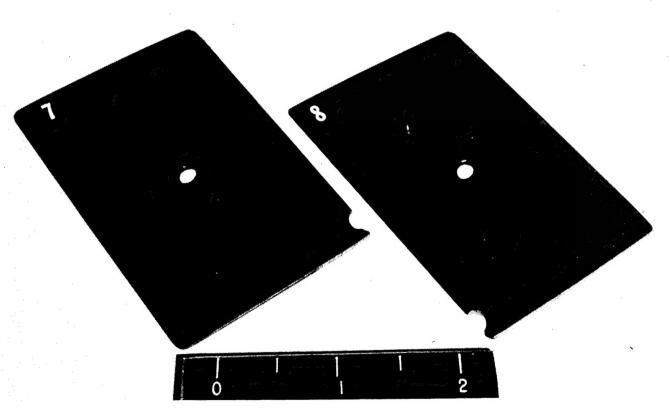
Figure 6. Metal specimens for test No. 4 after exposure and cleaning.

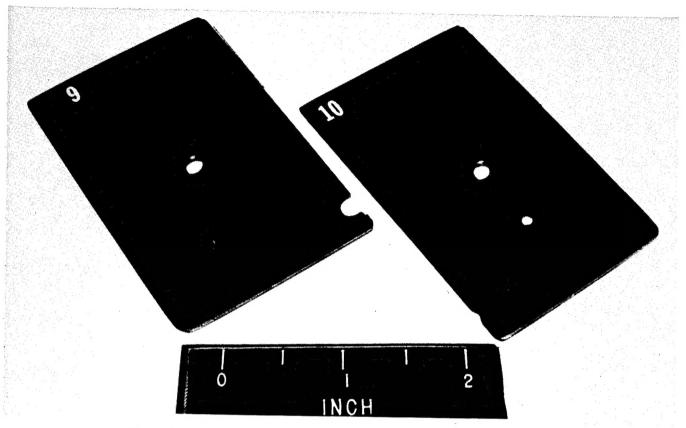
Figure 7. Metal specimens for test No. 5 after exposure and cleaning.

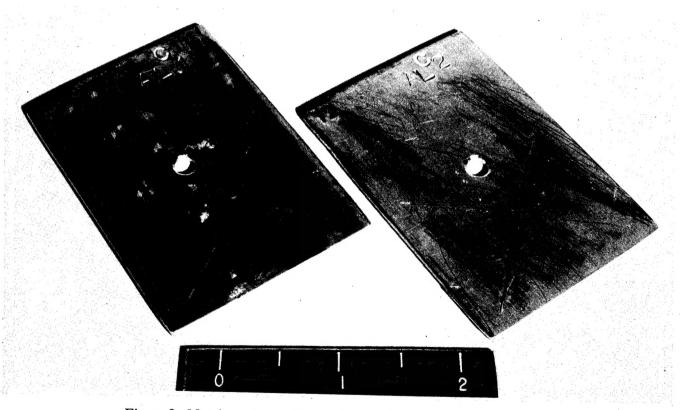
For the case of aluminum in test number 6, the condition of the aluminum was very good and the weight loss was rather small. Although Conoco grease was used as a final coat for the aluminum plates, it is likely that equally good results would have been obtained without Conoco grease.

Figure 8. Metal specimens for test No. 6 after exposure and cleaning.
